Slope Stability Investigation Portal Pad

SLOPE STABILITY INVESTIGATION
PORTAL PADS AND PORTAL ACCESS ROADS
GENWAL COAL MINE
HUNTINGTON, UTAH

JOB NO. 152

November 27, 1982

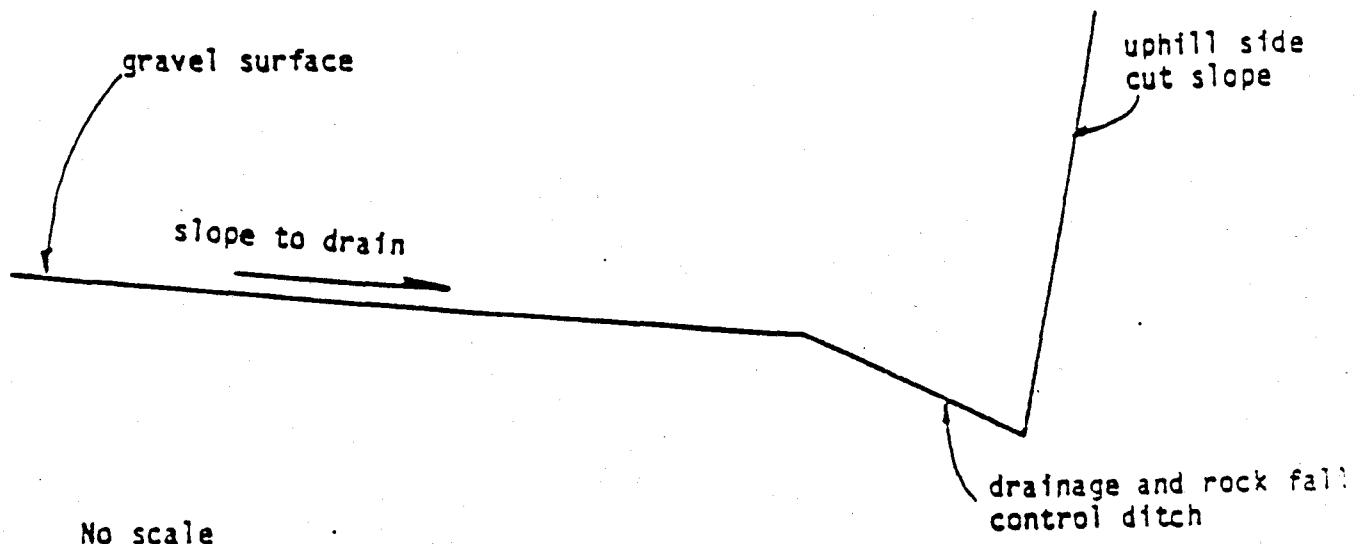
TYPICAL ROADWAY CROSS SECTION

could occur any time of the year due to weathering of the overhanging cliffs, and erosive forces causing the stranded rocks to loosen and roll downward. Both problems, in our opinion, can be minimized by providing a drainage (or rock fall ditch) as illustrated below. Details of the ditch construction are presented on Figure 6.

The following design and construction details should also be observed:

- (1) The construction activities will unavoidably alter and block the natural drainage paths along the proposed alignments. We recommend that culverts or other drainage means be provided for these areas.
- (2) The roadway should be graded toward the drainage (or rock fall) ditch to prevent ponding of water in the roadway.
